# **QA Test Report**

# PCA-6751

# (Random Vibration Test)

Report No: 03V016A0

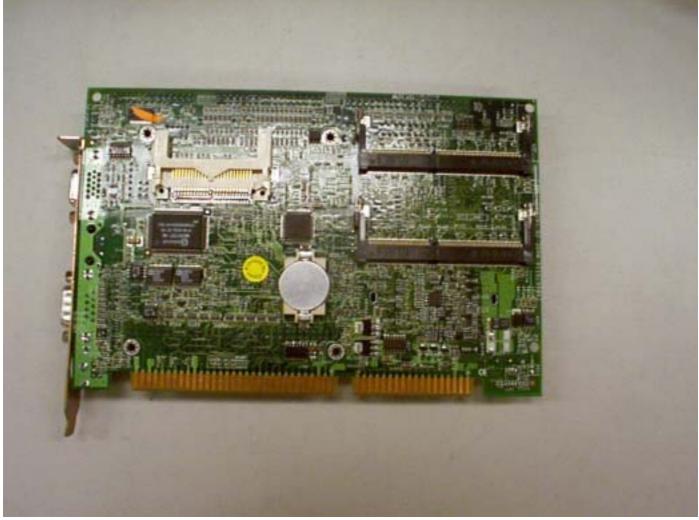
# Photo II:

## PCA-6751 rear view

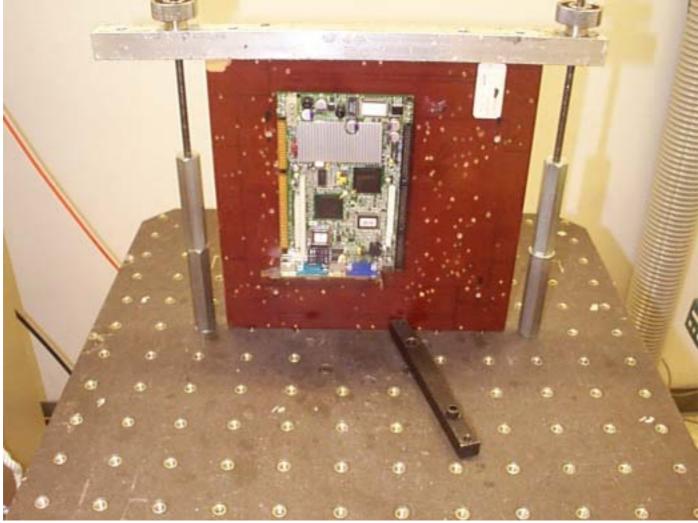
# Photo II:

**Y-axis**

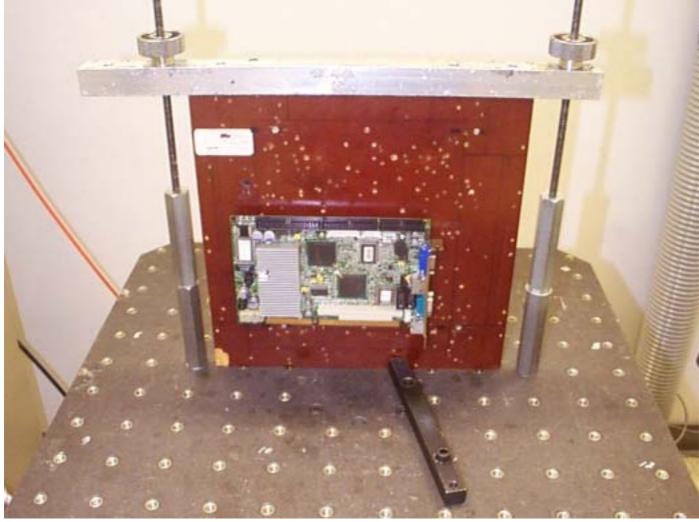
# Photo III:

**Z**-axis
